NASA TECHNICAL NOTE

NASA TN D-2741

PRELIMINARY INVESTIGATION OF  
FILAMENT-WOUND GLASS-REINFORCED  
PLASTICS AND LINERS FOR  
CRYOGENIC PRESSURE VESSELS

by Morgan P. Hanson, Hadley T. Richards,  
and Robert O. Hickel

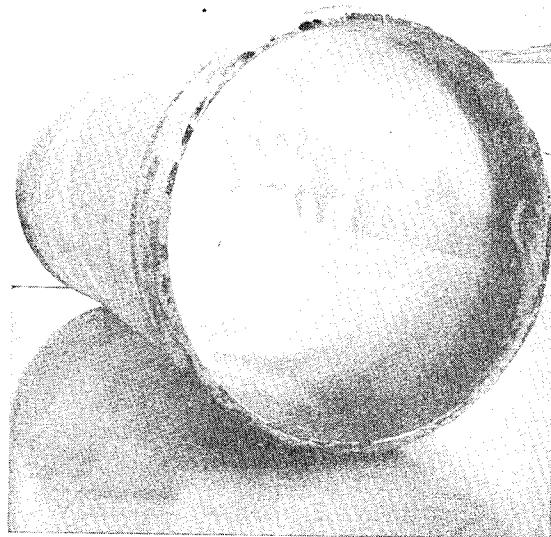
(a) Mylar film.

0.003-inch thick and made from plain film material. A longitudinal seam sealed with epoxy adhesive cured at 75° F was used; no backup material was employed. All liners were free floating with the exception of one Mylar A and one H-film liner that were adhered to the inside surface of the FRP tube. The major construction details and the test results for these liners are summarized in table III (p. 10). Typical failures of Mylar A and H-film liners are shown in figures 9(a) and (b).

It was intended that these liners would be cyclically strained to a value of about  $2\frac{1}{2}$  percent with liquid nitrogen as the pressurizing liquid. All seven liners failed, however, at strains of the order of 1 to  $1\frac{1}{2}$  percent during the first pressurization cycle. There did not appear to be any advantage in using a bonded liner over a free floating liner. Based upon the preliminary tests made of the unidirectional elongation characteristics of the films, failure at strains as low as 1 to 1.6 percent were not expected. Apparently the biaxial straining of the polymeric film-type liner materials in the pressure vessel has some effect on its strain characteristics. In order to further check the possibility that the biaxial straining of the liner materials had an adverse effect on its cyclic durability, a modified test assembly was employed for several tests. External longitudinal tie rods that connected the removable and reusable heads were employed to restrain the test tank ends with the result that, upon pressurization of the test tank, the longitudinal strain in the tank and liner materials was essentially zero. Three Mylar A liners were tested with this arrangement. A cyclic life of 1, 4, and 7 cycles was attained with the Mylar A material strained uniaxially (hoop direction only) to a value of  $2\frac{1}{2}$  percent.

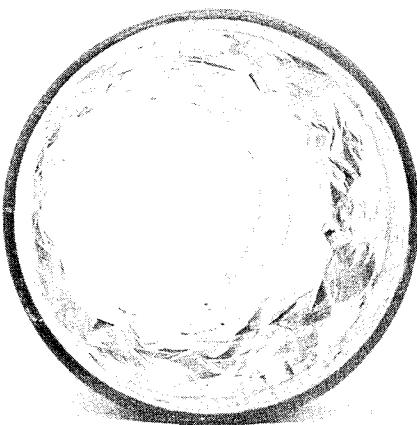
(c) Aluminum foil.

From table II it can be seen that a plain aluminum liner made from 1100-O aluminum that was 0.005-inch thick failed after only 1 cycle; actually the liner failed after pressurization for the second cycle had started. The pressure was relatively low and the strain at which the failure occurred during the second cycle was less than 1 percent. A photograph of the failed liner after removal of the end closures is shown in figure 9(c); it can be seen that the liner buckled randomly and, in some cases, quite severely.

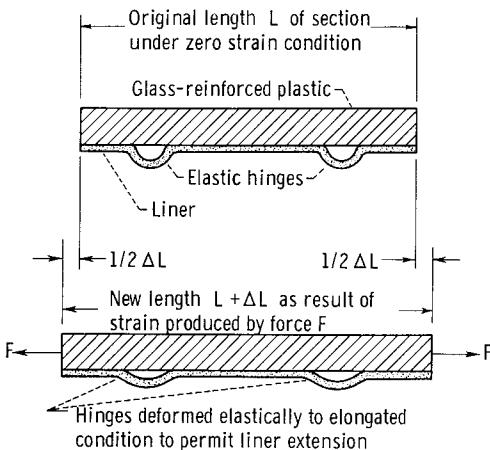
Figure 10. - Schematic diagram of liner design that permits liner to elongate.

The 8 successful cycles that were obtained with the stainless-steel liner might have been due in part to the buckling of the material. Assuming that the majority of the buckling was imposed upon the liner after the pressure was reduced to zero at the conclusion of the first cycle, the liner probably had many small wave-like buckled regions in the liner. When the liner was pressurized on successive cycles, it may have been possible that the smaller amplitude and smaller frequency waves did not become completely flattened under the influence of the internal pressure. If this were so, the buckled regions may have acted as hinges and permitted the liner to have some elastic extensibility up to the  $2\frac{1}{2}$ -percent strain condition. Because of its higher strength and modulus, it may have been conceivable for the stainless-steel material to resist the flattening action of the buckled regions better than the aluminum material and thus show better performance for the stainless-steel liner than for the aluminum liner. In any event, the stainless-steel liner failed eventually in the same general

ability of the order of 3 percent. Such metal liner concepts incorporating embossed patterns in the liner are discussed in the next section.

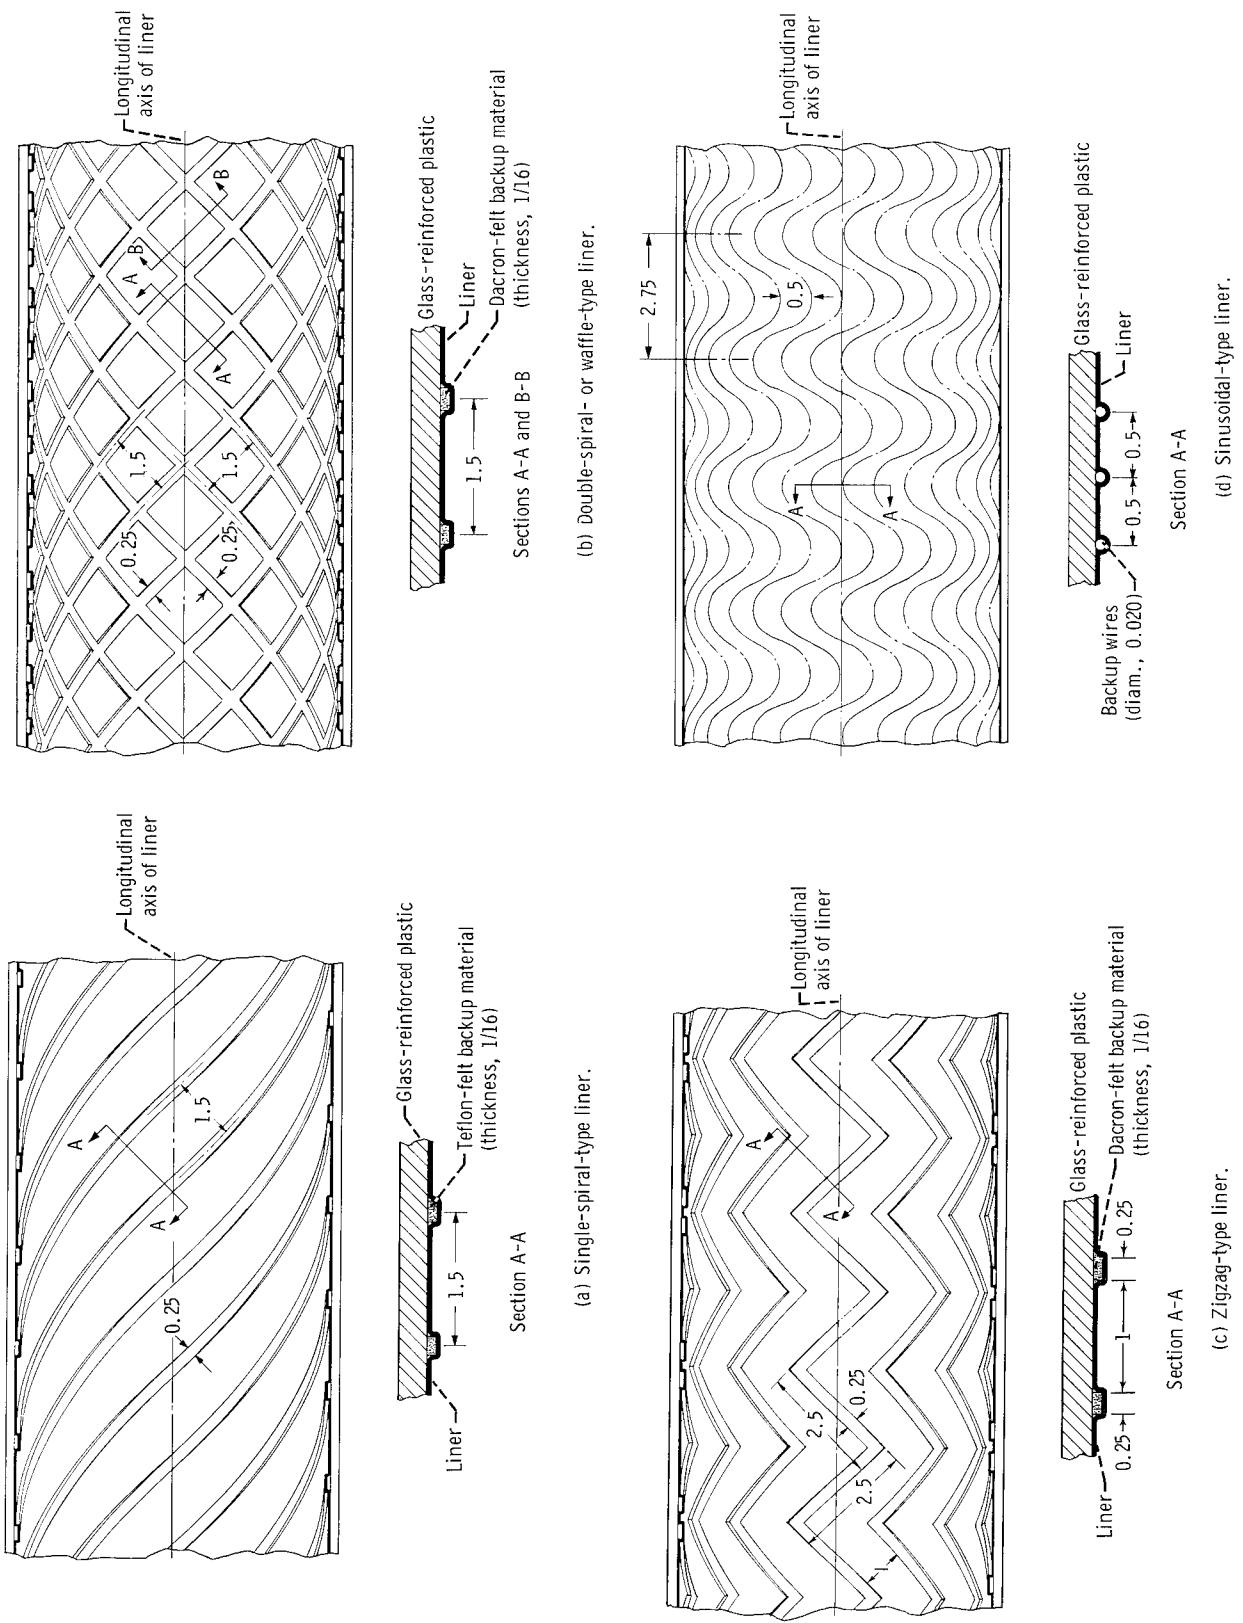
Figure 11. - Schematic diagrams of embossed liner configurations. (All dimensions in inches; not to scale.)

The four types of embossed liner configurations investigated herein are shown schematically in figure 11; this figure also indicates the liner material and the type of material that was used to fill and support the embossed portion of the liner. The orientation of the embossed liners with respect to the longitudinal axis of the test vessel is also indicated. It can be seen that the single spiral and the double spiral (fig. 11(a) and (b)) provide numerous hinges for circumferential and longitudinal strain. As the strain components within the liner approach more closely a direction that is parallel to the direction of the embossed convolutions, there are strains that are exactly parallel to and within the embossed convolutions. Since the convolutions extend continuously in what amounts to a direction that is coincident with some partic-

ular strain direction, these embossed spiral convolutions were thought to be a possible weakness and a source of potential failure for the single spiral and double spiral liner configurations. The zigzag and sinusoidal configurations (fig. 11(c) and (d)) were attempts to overcome this potential weakness in the embossed hinge concept. Both the zigzag and sinusoidal designs provide for discontinuous hinge directions with respect to any given strain direction. although the zigzag pattern does permit a strain component to be parallel and coincident with the embossed hinge, this does not occur over long uninterrupted distances. The sinusoidal configuration, because of its continuous hinge curvature and periodic reverse in curvature, essentially prevents strain components that are parallel and coincident with the hinges except for very short finite distances. In addition, the sinusoidal pattern eliminates the sharp right angle corners that exist in zigzag hinge configuration.

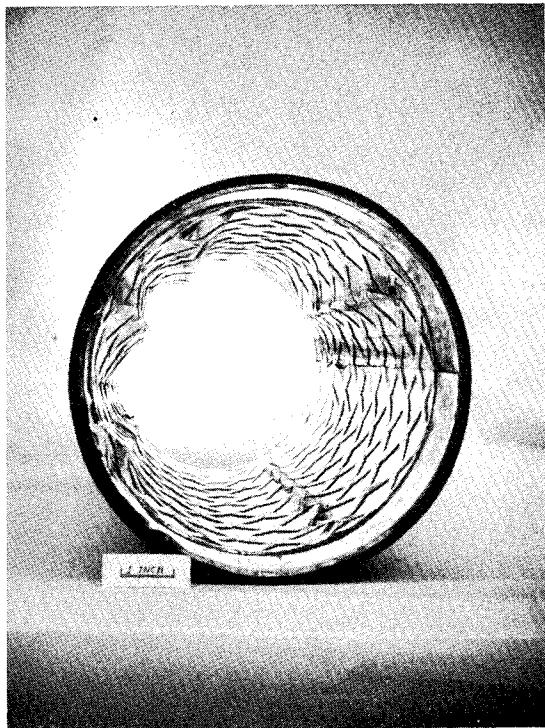
(a) Single spiral (5 cycles).

(b) Double spiral (1 cycle).

The results of cyclically straining and extending the various liner configurations under pressure loads that resulted in a strain of  $2\frac{1}{2}$  percent in the test cylinders is given in table II. The liner with single spiral convolutions (fig. 11(a)) was investigated first and was found to have a life of 5 cycles; although this was an improvement over that of the plain aluminum liner, it was not as good as that for the plain stainless-steel liner. A photograph of the failed spiral liner is shown in figure 12(a). A number of buckled regions at approximate right angles to the spiral convolutions are visible in addition to some randomly buckled regions. The failures in the liner appeared to originate in the ridges of the convolutions where strain components that were essentially parallel to the ridges apparently caused the aluminum foil to exceed its elastic limit. After several cycles, some of these regions where plastic flow had occurred apparently began to pinhole and then develop into a small tear causing the liner to leak excessively.

It was thought that perhaps a liner that was essentially a double spiral with the second group of spirals being at right angles to the first set might offer some improvement in cyclic life; this type of pattern results in the waffle configuration shown in figure 11(b). As shown in table II, this configuration operated successfully for only 1 cycle. Its mode of failure (shown in fig. 12(b)) was similar to that of the spiral convolution configuration in that the failures within the liner appeared to originate in regions where excessive plastic strain occurred in the ridges of the convolutions.

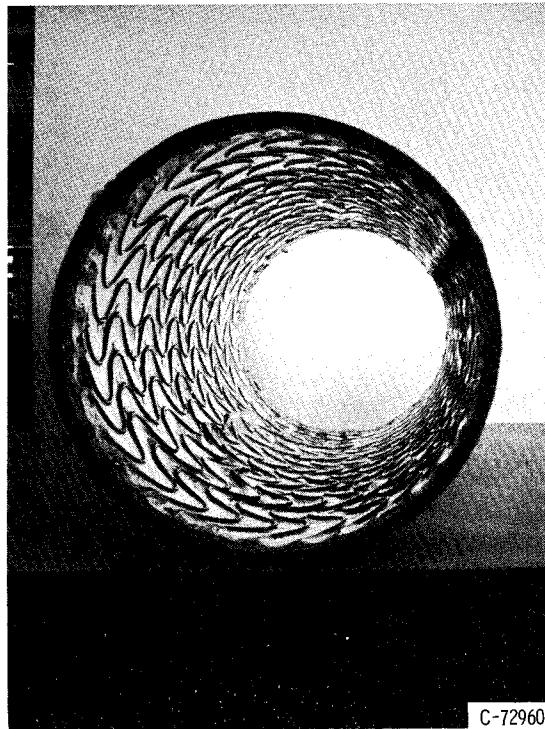
(c) Zig-zag (5 cycles).

(d) Sinusoidal (18 cycles).

A zigzag liner configuration such as that shown in figure 11(c) was investigated next. It was intended that this design might be an improvement over the spiral and waffle patterns in that the straight sections of the ridges forming the zigzag pattern were relatively short. As seen in table II (p. 8), this configuration failed after 5 strain cycles. Figure 12(c) shows the liner at the completion of the test. The failures originated in the valleys in a manner similar to that described previously for the spiral and waffle configurations. In addition, there was evidence that pinholing was occurring at the relatively sharp right angle corners of some of the zigzags.

With this sinusoidal configuration, a maximum of 18 cycles were completed before failure occurred. This liner was formed within a previous sinusoidal liner that had failed because of excessive stretching of the aluminum foil over the backup wires during pressurization. The first liner created a fillet at the juncture of the wires and the FRP tank inner wall and allowed the second liner to form without exceeding the maximum elongation capability of the aluminum foil. A cross section of this configuration is shown in figure 11(d). Figure 12(d) shows the liner at the completion of the test. Actually the failure of this liner was in the seam region and in several places where the liner was forced into a severely sharp radius at the junction of the backup wire with the wall of the reinforced plastic tank. It appears that the elimination of essentially straight and long ridges and sharp corners in the ridges improves the cyclic life of the liner.
